Bond degradation between FRP bars and concrete under sustained loads

A Thesis Submitted to the College of
Graduate Studies and Research
in Partial Fulfillment of the Requirements
for the Degree of Doctor of Philosophy
in the Department of Civil Engineering
University of Saskatchewan
Saskatoon

By
Fazlollah Shahidi

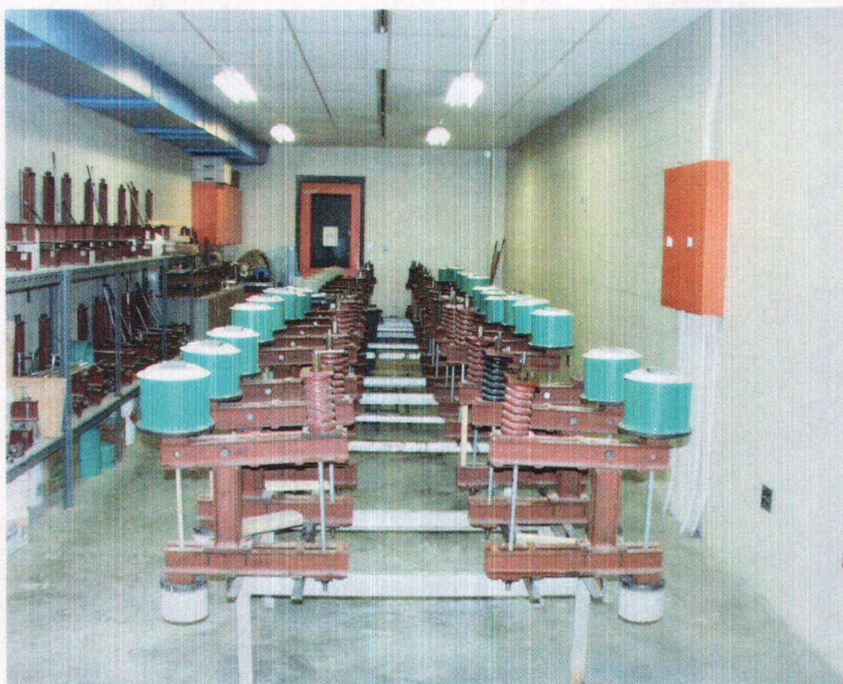
Figure 3.25. Test set-up for long term tests in Phase II.

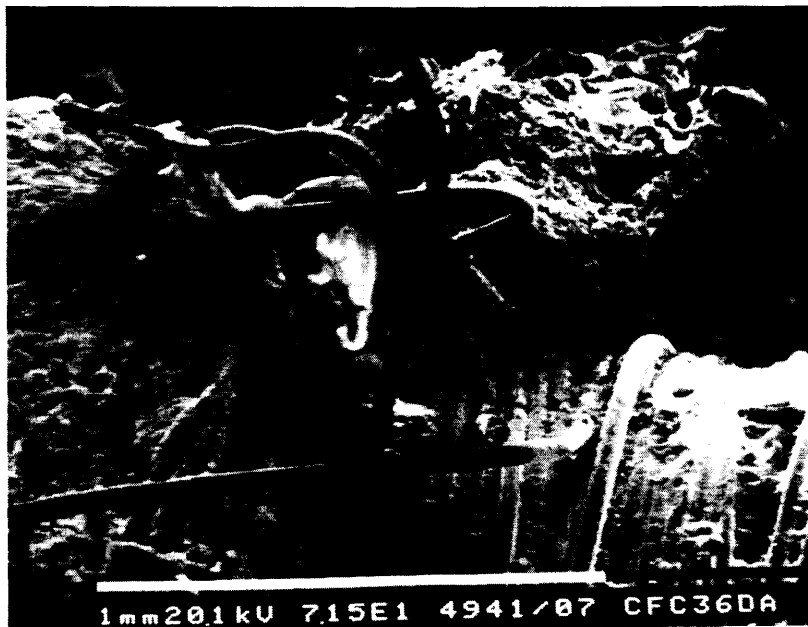
Figure 4.13. SEM image of the surface of the CFCC specimen (#3) with 90% load level after the test. Damage to coating (wrapped fibres) is evident.

The effect of sustained load on the CFCC bar surface is shown in Figure 4.13.

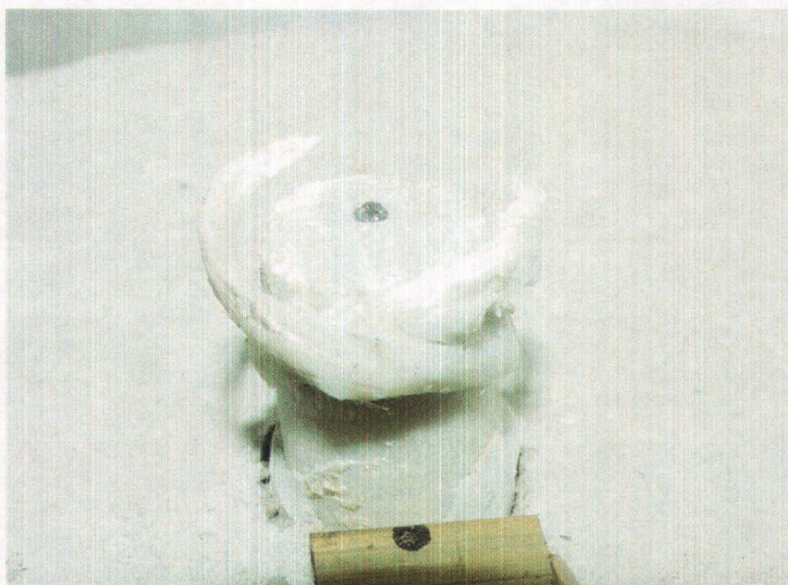
Figure 4.23. Photo of failed Isorod specimen at test end. The specimen experienced premature pullout failure at 66% load.

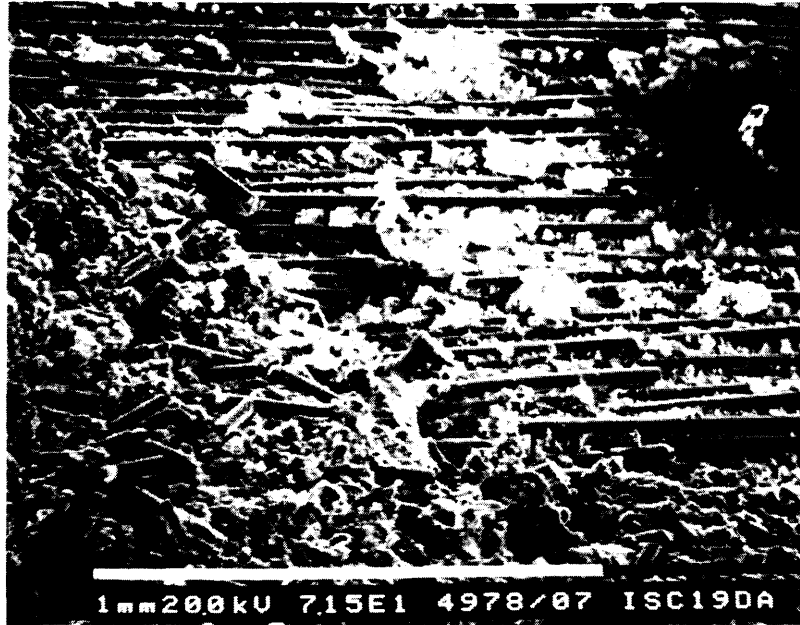
Figure 4.25. SEM image of surface of the Isorod (75% load level) after the test. Coating is totally damaged and fibres are broken.

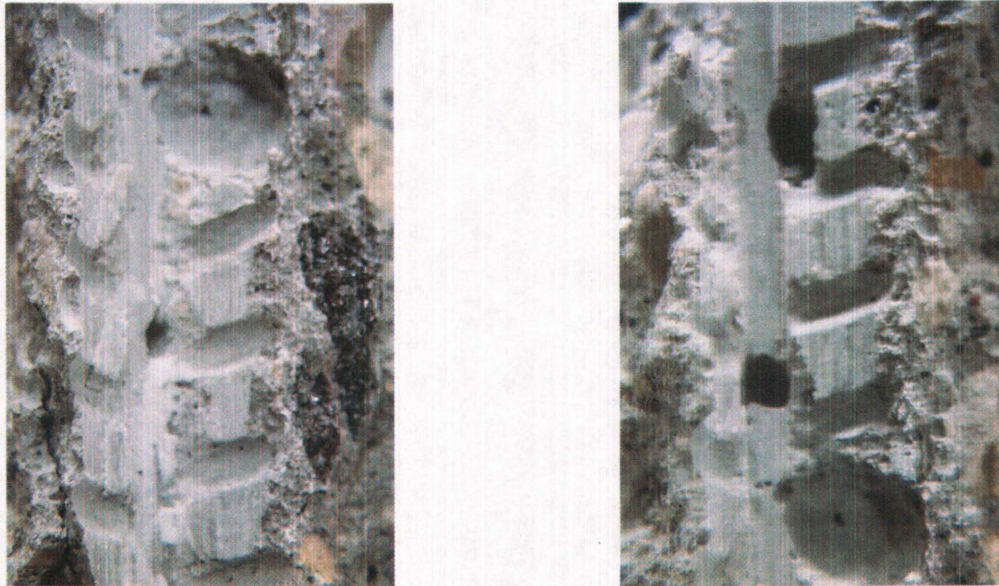
Figure 5.5. Photos showing inside of concrete cylinder at the anchor end of C-bar Specimen #1. Large voids could be seen in concrete surrounding the bar.

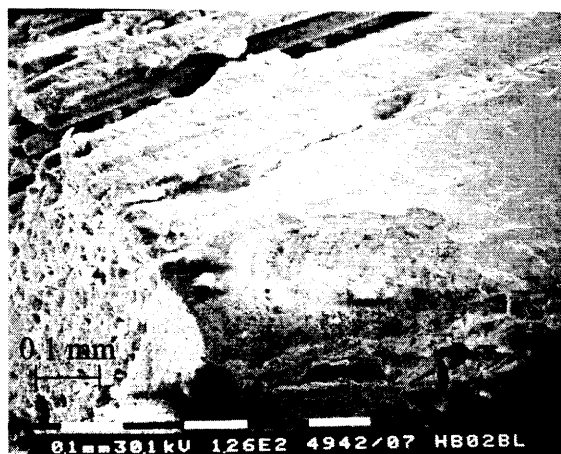
Figure 5.10. Longitudinal section of the sample taken from Specimen HB 25-75% Water #2 (bonded portion) displaying extension of the crack longitudinally.

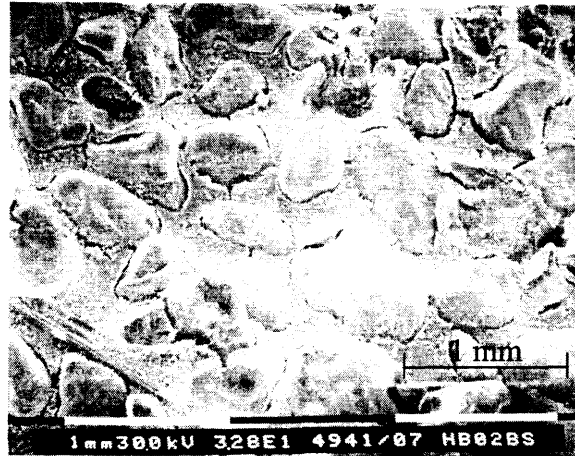
Figure 5.11. Image of the bar surface (Specimen HB 25-75% Water #2 – bonded portion). No damage to the coating of the bar is visible.

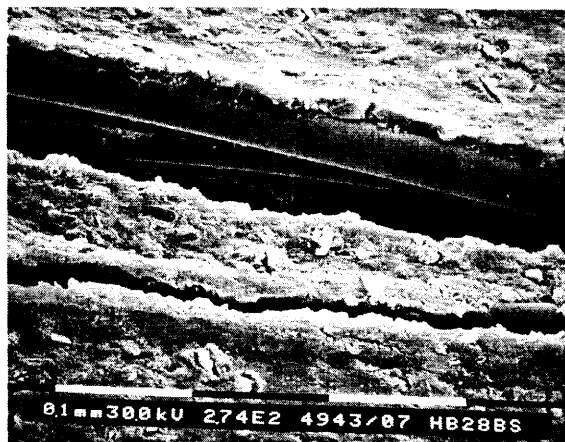
Figure 5.20. SEM image of the bar surface at the bonded portion (Specimen HB 50-75% Alkaline #2). Micro-cracks and exposed fibres are visible.

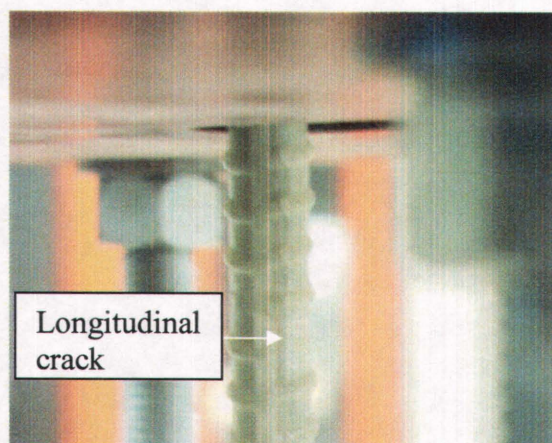
(a) Initial cracking at loaded end just after starting the static test.
